To: Daly, Eric[Daly.Eric@epa.gov]
From: Daly, Eric
Sent: Thur 6/8/2017 4:30:28 PM
Subject: FW: NFB GNBC Office Area

Attached are photos of what GNBC John pointed out to me.

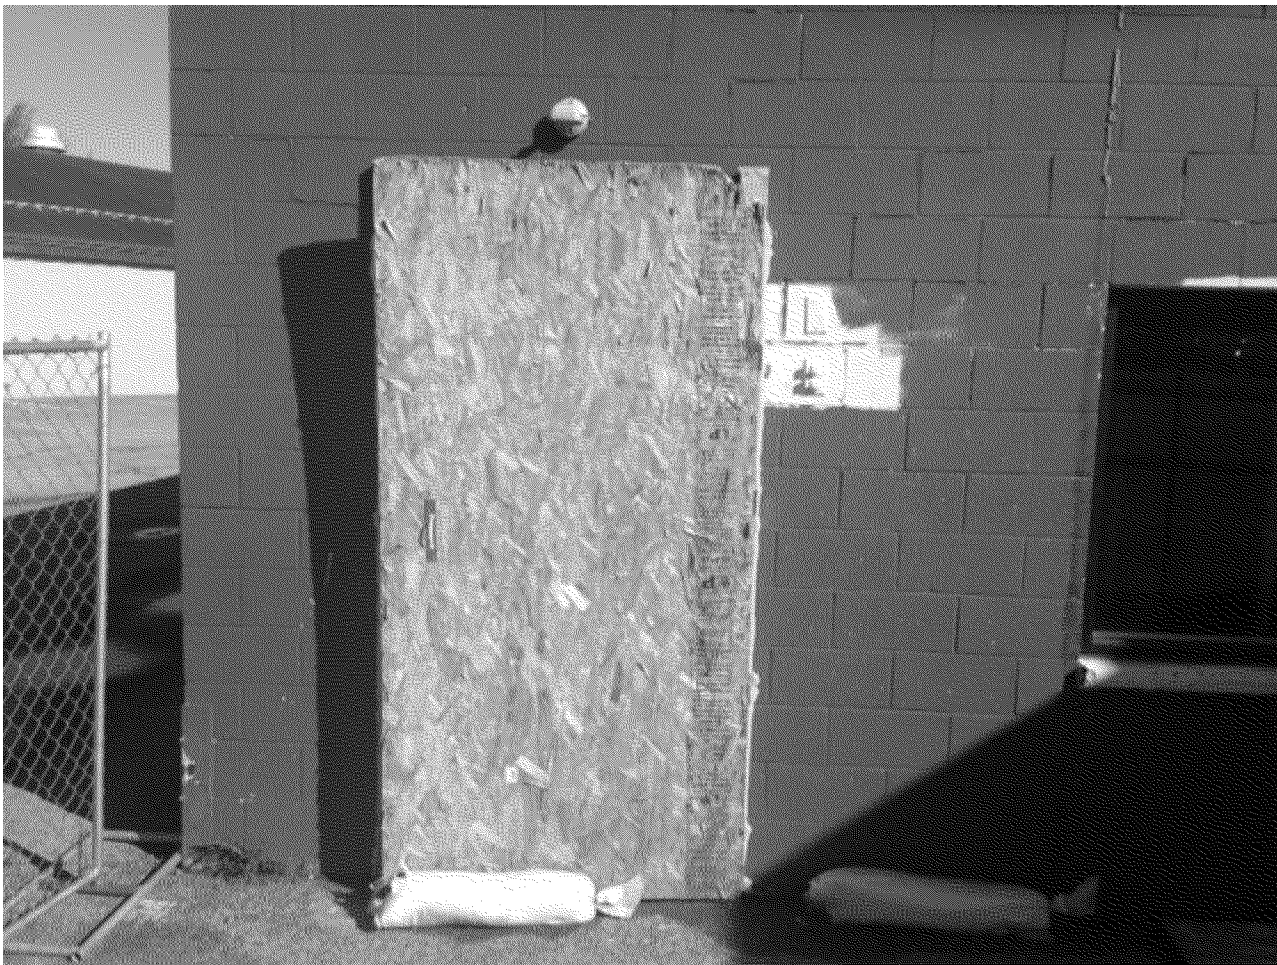
1. Temporary door is still on
2. Broken tile by bathroom drain
3. Window well sheetrock is pitted (New window still needs to be installed so not sure if they were waiting for the installation to do last spackle and paint)
4. Dented ceiling tile
5. Apparently visible seams on drywall (wall on Rapid Bowling alley side)
6. They wanted a door stop on the new interior door
